**Flood Control Project Maintenance
Levee Inspections**
LMA District Cover Sheet
Spring 2020 Levee Inspection Results

Lower San Joaquin Levee District

Spring 2020 Levee Inspection Results

Waterway			Bank	Unit Miles
Unit No. 01 San Joaquin River			Right	22.52
	Spring (March - May)	Summer (June - August)	(September - November) Fall	Winter (December - February)
Unit Maintenance Rating (Fall Only)				
Date of Inspection	4/21/2020 - 4/21/2020			
DWR Inspector	Corey Fujitani			
Accompanied By

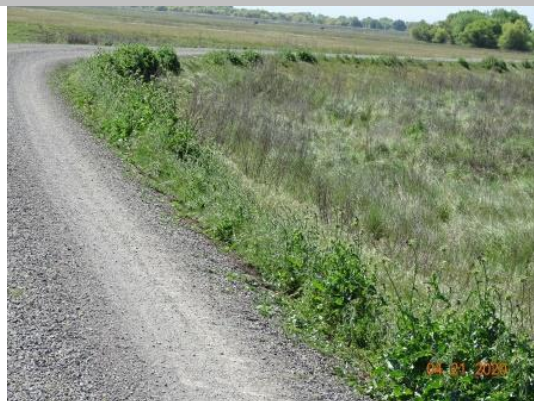
Photo 1 of 1 : SP_2020_NA0010_118_153_20200506_00301.jpg

LM Start	11.44	Rating **	U	Issue No.	153
LM End	11.57	Issue Type +	Ma	Location *	WS
Category	Earthen Levee			GPS Latitude/Longitude	
				Start	End
Item	Vegetation			37.274487 °	37.272563 °
				-120.825716 °	-120.825751 °
DWR ID	DWR_NA0010_01_s_2020_153				
Comment Code					
V1 : Control annual grass and weeds on the levee slopes and easements.					
Inspector Comment

Vegetation growing on the waterside slope. (Spring 2020)

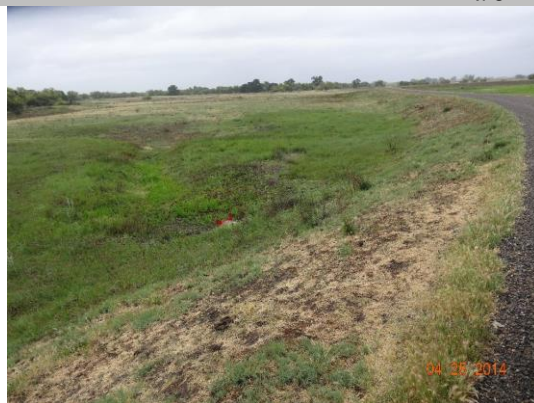
Photo 1 of 3 : UCIP_SP_2020_36103_65362.jpg

Comment Code						
Inspector Comment						
DS_ID:19634 FS_ID:36103 EP_NO: N/A Repair Type: Non-Urgent Crossing Status: Found UCIP Comments: 04/25/2014 Need to contact owner--landward side has been buried. It appears that soil was removed from levee toe, immediately upstream, and used to pile soil at landward side at crossing. (DWR UCIP - O. Magana) FIELD_STRUCT_DESC: 24-inch corrugated metal gravity drainage pipe through the levee, 10 feet below the crown. Flap gate on the waterside (WS) end. Brass cap No. 62 bench mark (BM) on the headwall on the landside (LS). [Additional Reference(s): DWR Levee Log, 2002. USACE San Joaquin O&M Manual 601.1, 1967, (HLM 11.48)]. FS Date: 4/25/2014

View of waterward side.

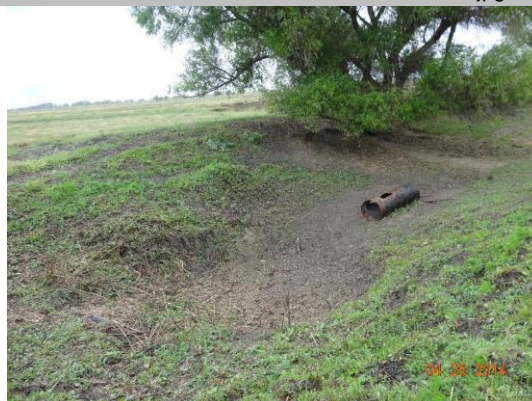
Photo 2 of 3 : UCIP_SP_2020_36105_65371.jpg

Landward side of crossing buried--damage pipe section visible on landward side.

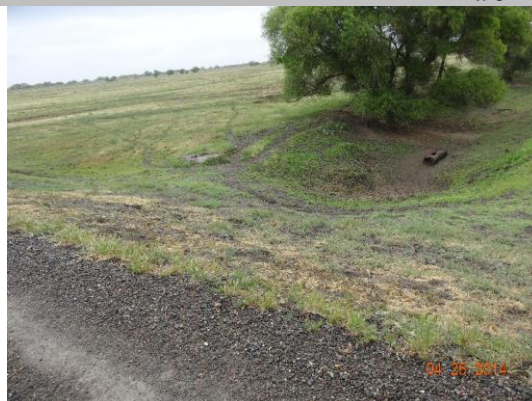
Photo 3 of 3 : UCIP_SP_2020_36105_65373.jpg

View of landward side.

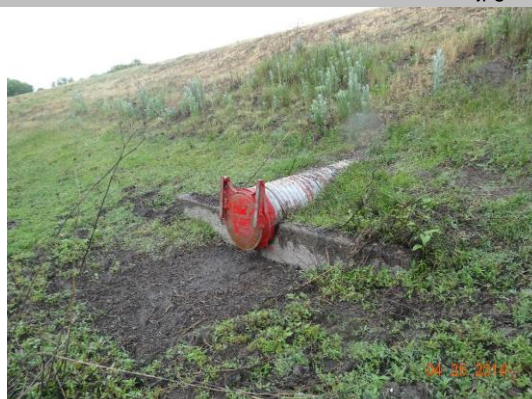
Photo 2 of 3 : UCIP_SP_2020_36106_65379.jpg

Flap gate and concrete headwall visible on waterward side.

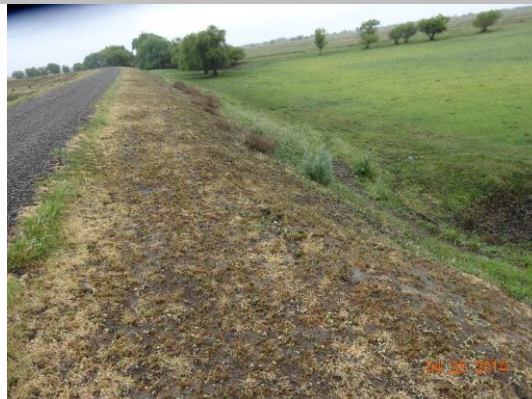
Photo 3 of 3 : UCIP_SP_2020_36106_65377.jpg

View of landward side.

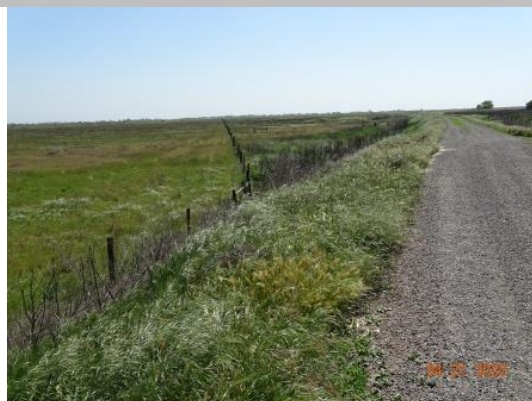
Photo 1 of 1 : SP_2020_NA0010_118_156_20200506_00302.jpg

LM Start	12.62	Rating **	U	Issue No.	156
LM End	17.46	Issue Type +	Ma	Location *	LS
Category	Earthen Levee			GPS Latitude/Longitude	
				Start	End
Item	Vegetation			37.258988 °	37.216004 °
				-120.826429 °	-120.778791 °
DWR ID	DWR_NA0010_01_s_2020_156				
Comment Code					
V1 : Control annual grass and weeds on the levee slopes and easements.					
Inspector Comment

Looking upstream along the landside slope. (Spring 2020)

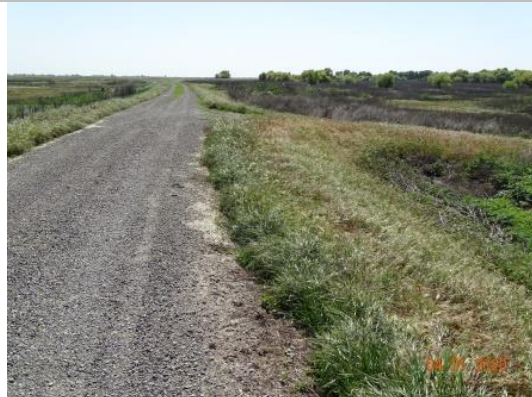
Photo 1 of 1 : SP_2020_NA0010_118_157_20200506_00303.jpg

LM Start	12.62	Rating **	U	Issue No.	157
LM End	17.46	Issue Type +	Ma	Location *	WS
Category	Earthen Levee			GPS Latitude/Longitude	
				Start	End
Item	Vegetation			37.258988 °	37.216004 °
				-120.826429 °	-120.778791 °
DWR ID	DWR_NA0010_01_s_2020_157				
Comment Code					
V1 : Control annual grass and weeds on the levee slopes and easements.					
Inspector Comment

View of the waterside slope looking upstream. (Spring 2020)

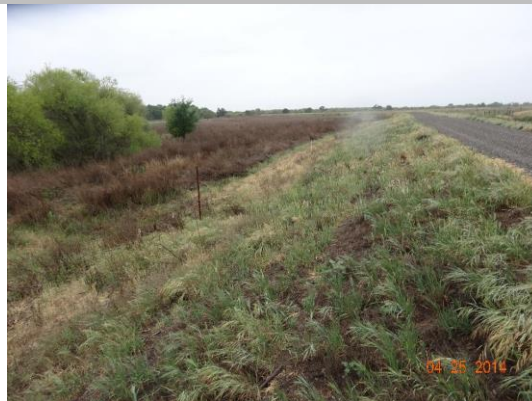
Photo 1 of 3 : UCIP_SP_2020_36146_65412.jpg

Comment Code						
Inspector Comment						
DS_ID:19637 FS_ID:36146 EP_NO: N/A Repair Type: Non-Urgent Crossing Status: Found UCIP Comments: 04/25/2014 Concrete headwall on landward side blocked by debris. Dense vegetation limits the inspector's visibility to identify signs of pipe failure (leaks) along the landward slope. Recommend removing vegetation along pipe alignment to conduct proper inspection of crossing. (DWR UCIP - O. Magana) FIELD_STRUCT_DESC: 24-inch corrugated metal gravity drainage pipe through the levee, 9.5 feet below the crown. Flap gate on the waterside (WS) end. Brass cap No. 60 bench mark (BM) on the headwall on the landside (LS). [Additional Reference(s): DWR Levee Log, 2002. USACE San Joaquin O&M Manual 601.1, 1967, (HLM 12.94)]. FS Date: 4/25/2014

View of waterward side.

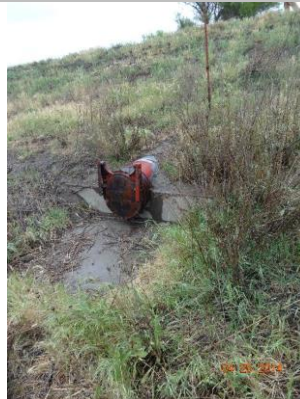
Photo 2 of 3 : UCIP_SP_2020_36146_65411.jpg

Flap gate and concrete headwall visible on waterward side.

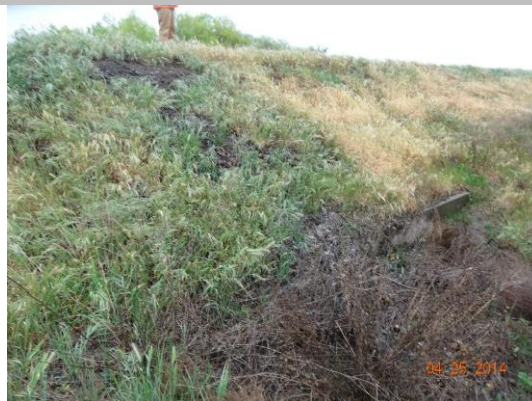
Photo 3 of 3 : UCIP_SP_2020_36146_65410.jpg

View of landward side--concrete headwall visible covered by dense vegetation.

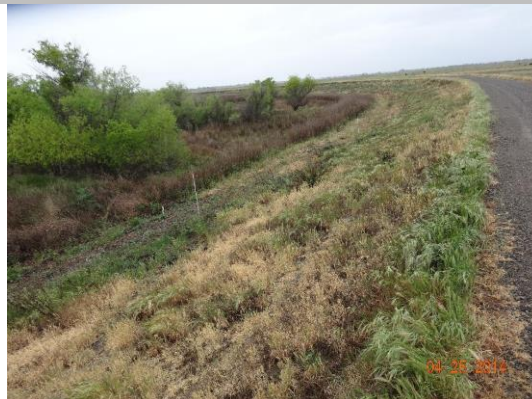
Photo 1 of 3 : UCIP_SP_2020_36109_65389.jpg

Comment Code					
Inspector Comment					
DS_ID:19638 FS_ID:36109 EP_NO: N/A Repair Type: Non-Urgent Crossing Status: Found UCIP Comments: 04/25/2014 Dense vegetation limits the inspector's visibility to identify signs of pipe failure (leaks) along the landward slope. Concrete headwall blocked by debris located on landward toe. Recommend clearing debris from landward slope and toe. (DWR UCIP - O. Magana) FIELD_STRUCT_DESC: 24-inch corrugated metal gravity drainage pipe through the levee, 14.2 feet below the crown. Flap gate on the waterside (WS) end. Brass cap No. 60 bench mark (BM) on the headwall on the landside (LS). [Additional Reference(s): DWR Levee Log, 2002. USACE San Joaquin O&M Manual 601.1, 1967, (HLM 13.48)]. FS Date: 4/25/2014

View of waterward side.

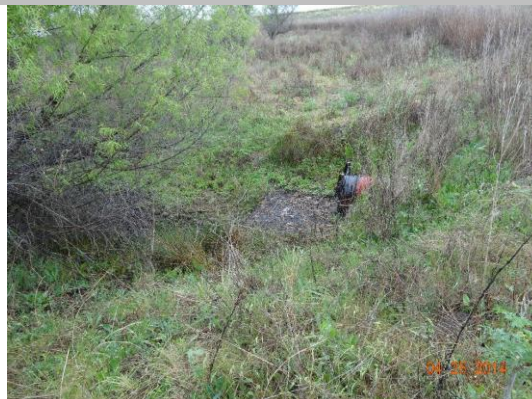
Photo 2 of 3 : UCIP_SP_2020_36109_65387.jpg

View of flap gate and pipe through levee on waterward side.

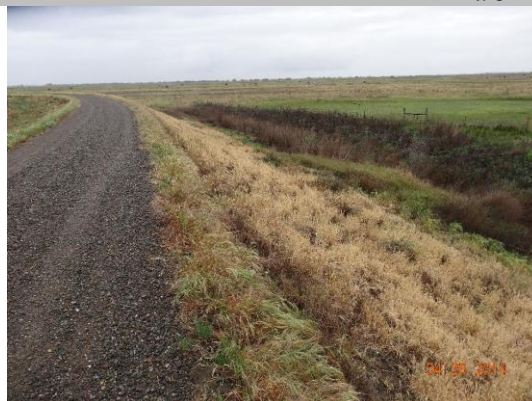
Photo 3 of 3 : UCIP_SP_2020_36109_65388.jpg

View of landward side.

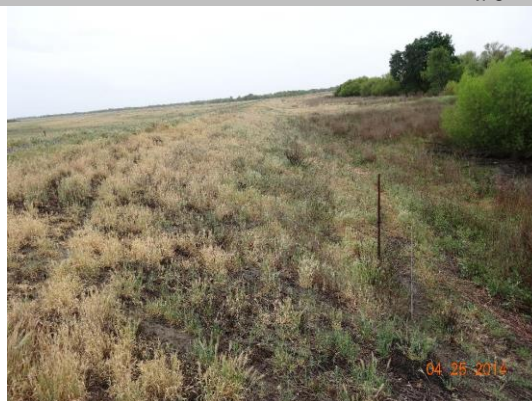
Photo 1 of 3 : UCIP_SP_2020_39256_65418.jpg

DS_ID:19639
FS_ID:39256
EP_NO: N/A
Repair Type: Non-Urgent
Crossing Status: Found
UCIP Comments: 04/25/2014 No access to waterward toe due to fence. Unable to find the concrete headwall and flap gate on waterward side past fence. Also dense vegetation limits the inspector's visibility to identify signs of pipe failure (leaks) along the waterward slope. Recommend removing vegetation along pipe alignment to conduct proper inspection of structure. Also need access past fence on waterward side. (DWR UCIP - O. Magana)
FIELD_STRUCT_DESC: 24-inch corrugated metal gravity drainage pipe through the levee, 14.5 feet below the crown. Flap gate on the waterside (WS) end. Brass cap No. 60 bench mark (BM) on the headwall on the landside (LS). [Additional Reference(s): DWR Levee Log, 2002. USACE San Joaquin O&M Manual 601.1, 1967, (HLM 13.58)].
FS Date: 4/25/2014

View of waterward side.

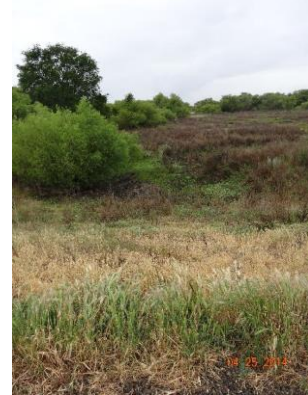
Photo 2 of 3 : UCIP_SP_2020_39256_65417.jpg

Dense vegetation on waterward side.

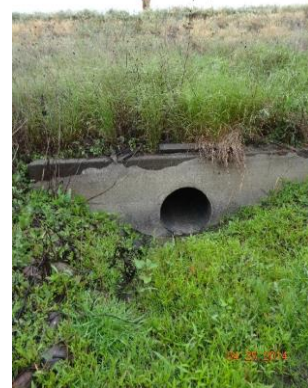
Photo 3 of 3 : UCIP_SP_2020_39256_65416.jpg

Concrete headwall visible from landward side.

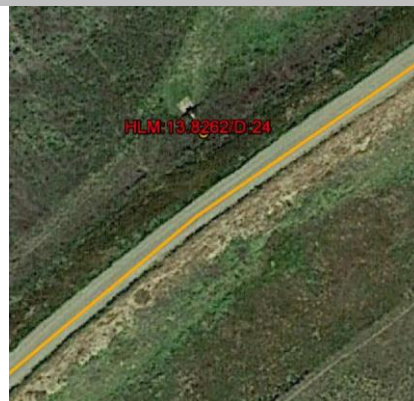
Photo 1 of 1 : UCIP_SP_2020_36544_66286.jpg

Comment Code						
Inspector Comment						
DS_ID:19640 FS_ID:36544 EP_NO: N/A Repair Type: Non-Urgent Crossing Status: Indicator Found UCIP Comments: 04/25/2014 No photos available--missed crossing. Aerial photograph indicates crossing is present. Need to confirm if crossing is still present on waterward side. (DWR UCIP - O. Magana) FIELD_STRUCT_DESC: 24-inch corrugated metal gravity drainage pipe through the levee, 11 feet below the crown. Flap gate on the waterside (WS) end. Brass cap No. 60 bench mark (BM) on the headwall on the landside (LS). [Additional Reference(s): DWR Levee Log, 2002. USACE San Joaquin O&M Manual 601.1, 1967, (HLM 13.81)]. FS Date: 4/25/2014

Indicators of crossing visible from aerial photograph.

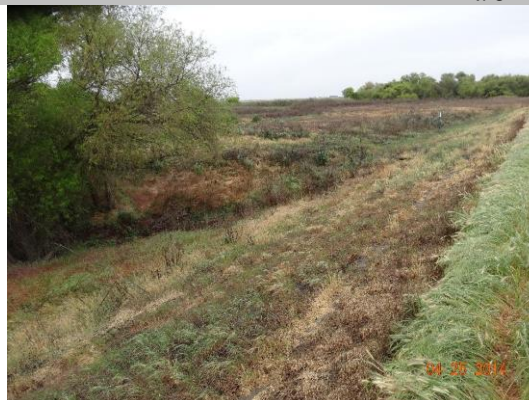
Photo 1 of 3 : UCIP_SP_2020_36166_65449.jpg

Comment Code						
Inspector Comment						
DS_ID:19641 FS_ID:36166 EP_NO: N/A Repair Type: Non-Urgent Crossing Status: Found UCIP Comments: 04/25/2014 Dense vegetation limits the inspector's visibility to identify signs of pipe failure (leaks) along the slopes. Recommend removing vegetation along pipe alignment to conduct proper inspection of structure. (DWR UCIP - O. Magana) FIELD_STRUCT_DESC: 24-inch corrugated metal gravity drainage pipe through the levee, 13 feet below the crown. Flap gate on the waterside (WS) end. Brass cap No. 60 bench mark (BM) on the headwall on the landside (LS). [Additional Reference(s): DWR Levee Log, 2002. USACE San Joaquin O&M Manual 601.1, 1967, (HLM 14.21)]. FS Date: 4/25/2014

View of waterward side.

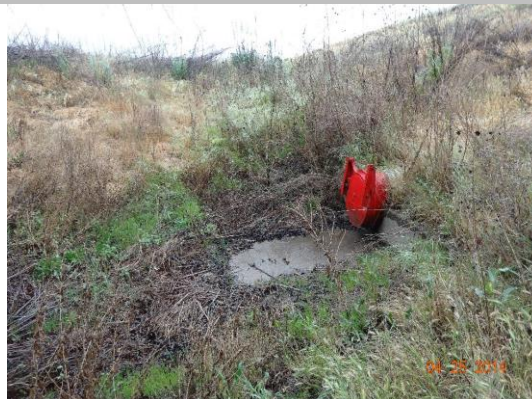
Photo 2 of 3 : UCIP_SP_2020_36166_65452.jpg

View of concrete headwall, concrete apron, and flap gate on waterward side.

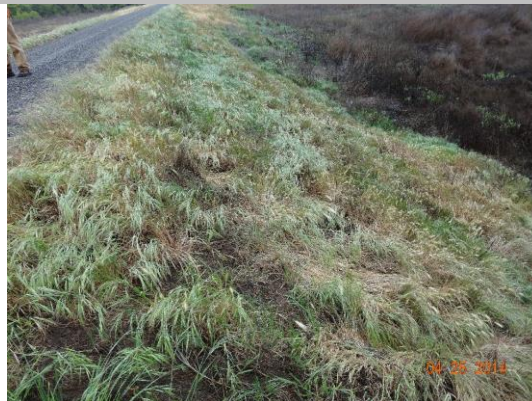
Photo 3 of 3 : UCIP_SP_2020_36166_65448.jpg

View of landward side.

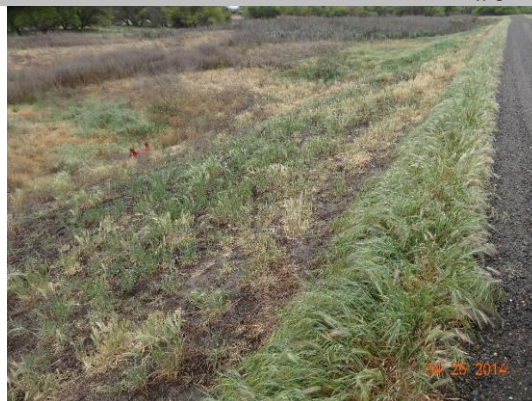
Photo 1 of 3 : UCIP_SP_2020_36167_65455.jpg

Comment Code					
Inspector Comment					
DS_ID:19642 FS_ID:36167 EP_NO: N/A Repair Type: Non-Urgent Crossing Status: Found UCIP Comments: 04/25/2014 Dense vegetation limits the inspector's visibility to identify signs of pipe failure (leaks) along the landward slope and toe. Recommend removing vegetation along pipe alignment to conduct proper inspection of structure. (DWR UCIP - O. Magana) FIELD_STRUCT_DESC: 24-inch corrugated metal gravity drainage pipe through the levee, 9.7 feet below the crown. Flap gate on the waterside (WS) end. Brass cap No. 60 bench mark (BM) on the headwall on the landside (LS). [Additional Reference(s): DWR Levee Log, 2002. USACE San Joaquin O&M Manual 601.1, 1967, (HLM 14.65)]. FS Date: 4/25/2014

View of waterward side.

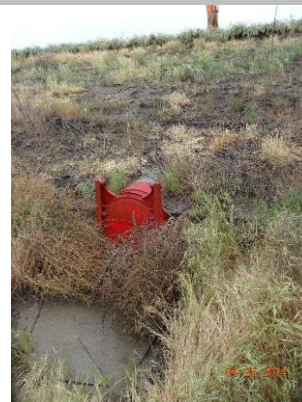
Photo 2 of 3 : UCIP_SP_2020_36167_65454.jpg

Flap gate, concrete headwall, and concrete apron located on waterward toe.

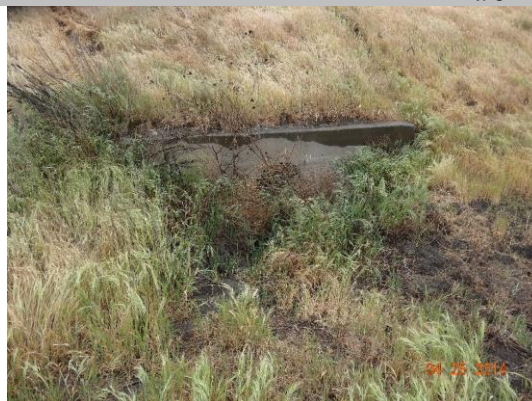
Photo 3 of 3 : UCIP_SP_2020_36167_65453.jpg

Concrete headwall located on landward toe.

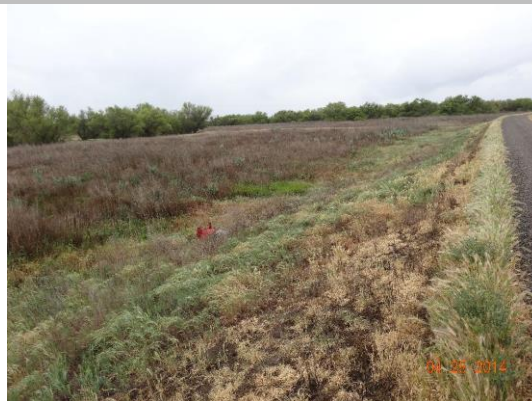
Photo 1 of 3 : UCIP_SP_2020_36168_65459.jpg

DS_ID:19643
 FS_ID:36168
 EP_NO: N/A
 Repair Type: Non-Urgent
 Crossing Status: Found
 UCIP Comments: 04/25/2014 Dense vegetation limits the inspector's visibility to identify signs of pipe failure (leaks) along the landward slope. Recommend removing vegetation along pipe alignment to conduct proper inspection of structure. (DWR UCIP - O. Magana)
 FIELD_STRUCT_DESC: 24-inch corrugated metal gravity drainage pipe through the levee, 9.2 feet below the crown. Flap gate on the waterside (WS) end. Brass cap No. 60 bench mark (BM) on the headwall on the landside (LS). [Additional Reference(s): DWR Levee Log, 2002. USACE San Joaquin O&M Manual 601.1, 1967, (HLM 15.29)].
 FS Date: 4/25/2014

View of waterward side.

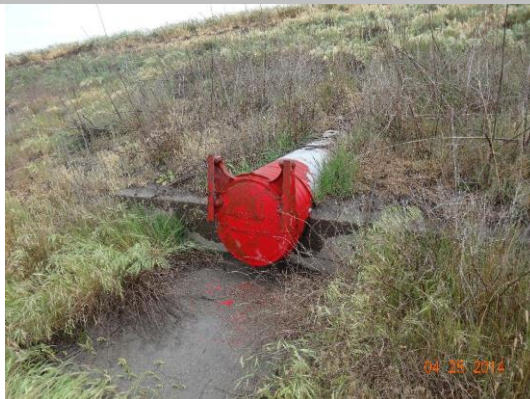
Photo 2 of 3 : UCIP_SP_2020_36168_65457.jpg

Concrete headwall, flap gate, and concrete apron located on waterward side.

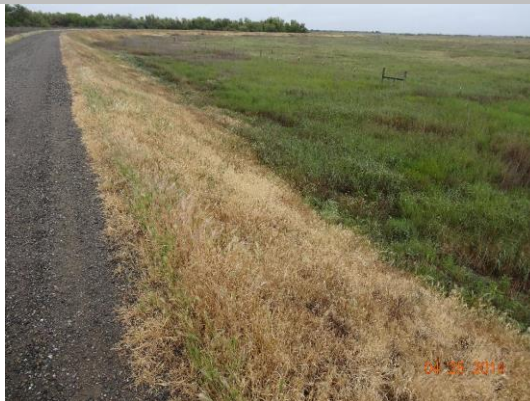
Photo 3 of 3 : UCIP_SP_2020_36168_65458.jpg

View of landward side.

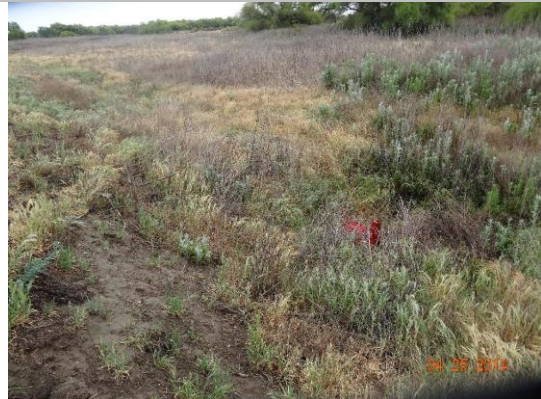
Photo 1 of 3 : UCIP_SP_2020_36169_65464.jpg

Comment Code					
Inspector Comment					
DS_ID:19644 FS_ID:36169 EP_NO: N/A Repair Type: Non-Urgent Crossing Status: Found UCIP Comments: 04/25/2014 Dense vegetation limits the inspector's visibility to identify signs of pipe failure (leaks) along the waterward and landward slopes. Recommend removing vegetation along pipe alignment to conduct proper inspection of structure. (DWR UCIP - O. Magana) FIELD_STRUCT_DESC: 24-inch corrugated metal gravity drainage pipe through the levee, 8.5 feet below the crown. Flap gate on the waterside (WS) end. Brass cap No. 60 bench mark (BM) on the headwall on the landside (LS). [Additional Reference(s): DWR Levee Log, 2002. USACE San Joaquin O&M Manual 601.1, 1967, (HLM 15.57)]. FS Date: 4/25/2014

View of waterward side--flap gate visible through dense vegetation.

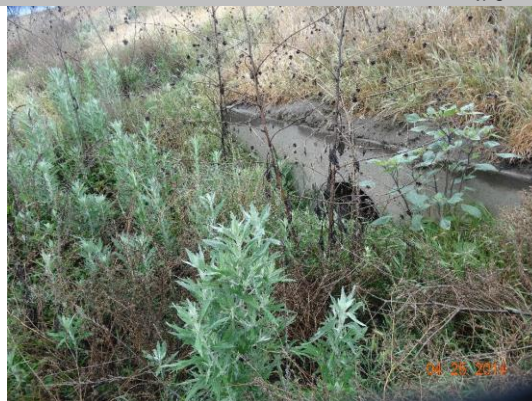
Photo 3 of 3 : UCIP_SP_2020_36169_65462.jpg

Concrete headwall visible on landward toe--dense vegetation blocking inlet.

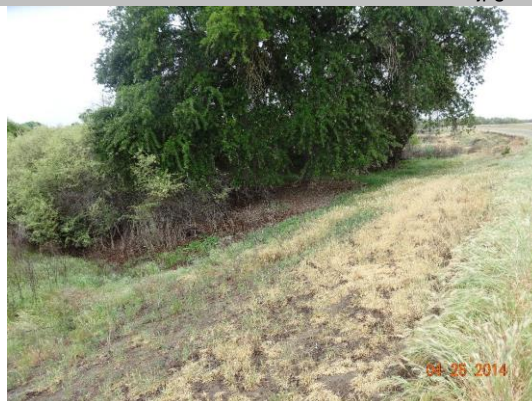
Photo 1 of 3 : UCIP_SP_2020_36171_65471.jpg

DS_ID:19645
 FS_ID:36171
 EP_NO: N/A
 Repair Type: Non-Urgent
 Crossing Status: Found
 UCIP Comments: 04/25/2014 Dense vegetation limits the inspector's visibility to identify signs of pipe failure (leaks) along the waterward and landward slope. Recommend removing vegetation along pipe alignment to conduct proper inspection of structure. (DWR UCIP - O. Magana)
 FIELD_STRUCT_DESC: 24-inch corrugated metal gravity drainage pipe through the levee, 11 feet below the crown. Flap gate on the waterside (WS) end. Brass cap No. 60 bench mark (BM) on the headwall on the landside (LS). [Additional Reference(s): DWR Levee Log, 2002. USACE San Joaquin O&M Manual 601.1, 1967, (HLM 15.81)].
 FS Date: 4/25/2014

View of waterward side.

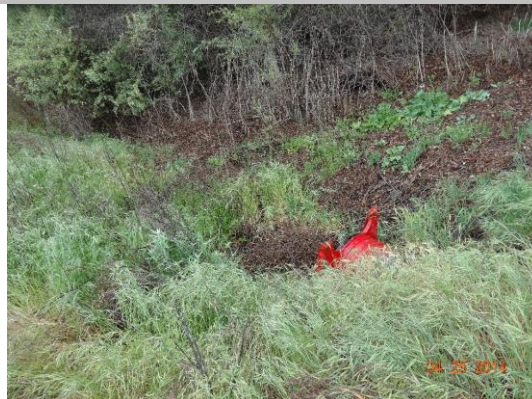
Photo 2 of 3 : UCIP_SP_2020_36171_65470.jpg

Flap gate visible on waterward side.

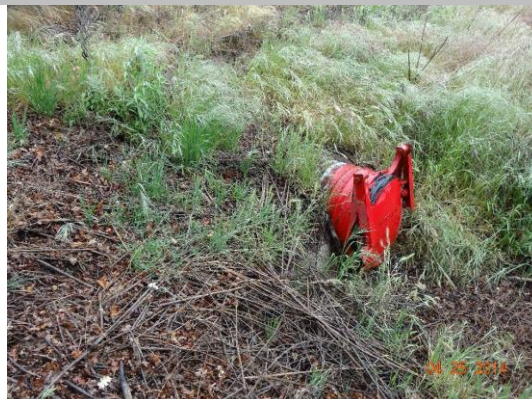
Photo 3 of 3 : UCIP_SP_2020_36171_65469.jpg

Side view of pipe and flap gate on waterward side.

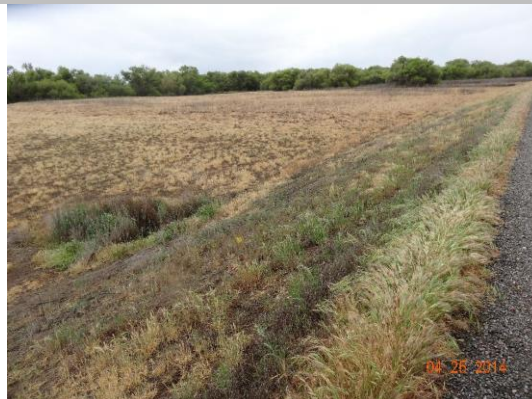
Photo 1 of 3 : UCIP_SP_2020_36172_65476.jpg

DS_ID:19646
FS_ID:36172
EP_NO: N/A
Repair Type: Non-Urgent
Crossing Status: Found
UCIP Comments: 04/25/2014 Dense vegetation limits the inspector's visibility to identify signs of pipe failure (leaks) along the waterward and landward slopes. Recommend removing vegetation along pipe alignment to conduct proper inspection of structure and appurtenances. (DWR UCIP - O. Magana)
FIELD_STRUCT_DESC: 24-inch corrugated metal gravity drainage pipe through the levee, 11.3 feet below the crown. Flap gate on the waterside (WS) end. Brass cap No. 50 bench mark (BM) on the headwall on the landside (LS). [Additional Reference(s): DWR Levee Log, 2002. USACE San Joaquin O&M Manual 601.1, 1967, (HLM 16.09)].
FS Date: 4/25/2014

View of waterward side.

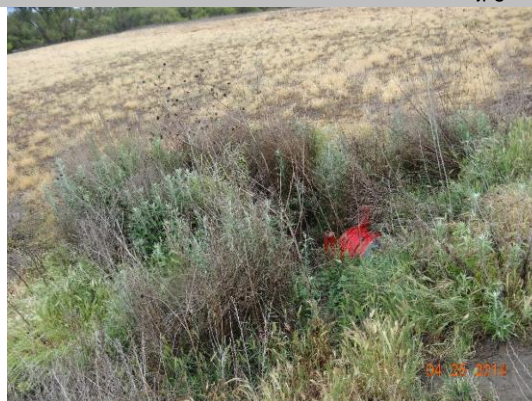
Photo 2 of 3 : UCIP_SP_2020_36172_65475.jpg

Flap gate visible on waterward toe.

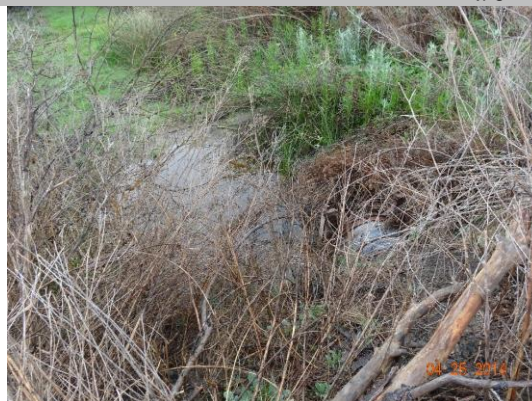
Photo 2 of 3 : UCIP_SP_2020_39257_65479.jpg

Crossing visible on waterward side under dense vegetation.

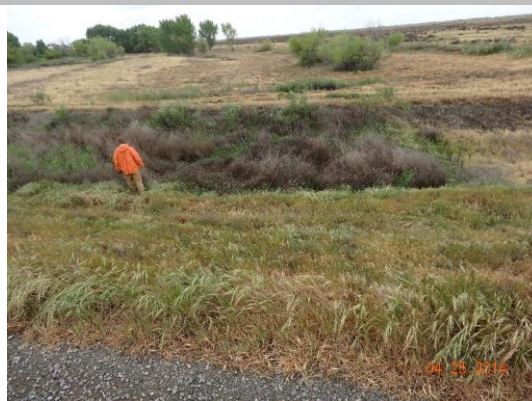
Photo 3 of 3 : UCIP_SP_2020_39257_65478.jpg

View of landward side.

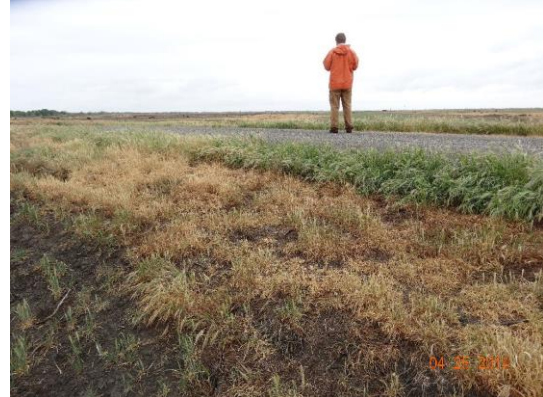
Photo 1 of 3 : UCIP_SP_2020_39258_66288.jpg

Comment Code						
Inspector Comment						
DS_ID:19648 FS_ID:39258 EP_NO: N/A Repair Type: Non-Urgent Crossing Status: Found UCIP Comments: 04/25/2014 Dense vegetation limits the inspector's visibility to identify signs of pipe failure (leaks) along the waterward and landward slopes. Recommend removing vegetation along pipe alignment to conduct proper inspection of structure. Unable to find pipe on landward side. (DWR UCIP - O. Magana) FIELD_STRUCT_DESC: 24-inch corrugated metal gravity drainage pipe through the levee, 11.4 feet below the crown. Flap gate on the waterside (WS) end. Brass cap No. 50 bench mark (BM) on the headwall on the landside (LS). [Additional Reference(s): DWR Levee Log, 2002. USACE San Joaquin O&M Manual 601.1, 1967, (HLM 16.72)]. FS Date: 4/25/2014

View of levee crown at crossing.

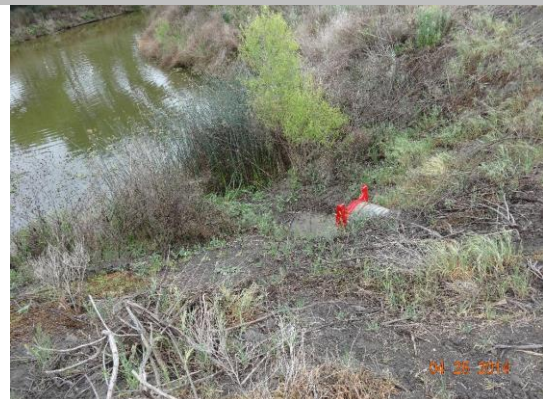
Photo 2 of 3 : UCIP_SP_2020_39258_66289.jpg

View of waterward side.

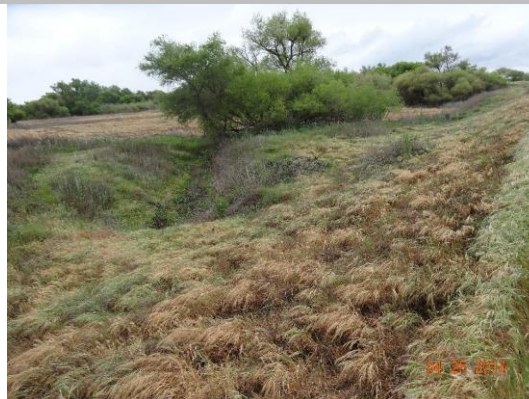
Photo 1 of 3 : UCIP_SP_2020_39259_65518.jpg

DS_ID:19577
 FS_ID:39259
 EP_NO: N/A
 Repair Type: Non-Urgent
 Crossing Status: Found
 UCIP Comments: 04/25/2014 Dense vegetation limits the inspector's visibility to identify signs of pipe failure (leaks) along the waterward and landward slopes. Concrete headwall is buried by dense vegetation. Recommend removing vegetation along pipe alignment to conduct proper inspection of structure. (DWR UCIP - O. Magana)
 FIELD_STRUCT_DESC: 24-inch corrugated metal gravity drainage pipe through the levee, 11.5 feet below the crown. Flap gate on the waterside (WS) end. Brass cap No. 50 bench mark (BM) on the headwall on the landside (LS). [Additional Reference(s): DWR Levee Log, 2002. USACE San Joaquin O&M Manual 601.1, 1967, (HLM 17.01)].
 FS Date: 4/25/2014

View of waterward side.

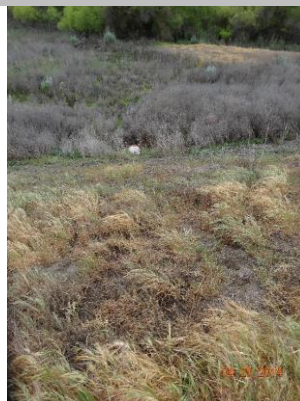
Photo 1 of 3 : UCIP_SP_2020_39260_65525.jpg

Comment Code						
Inspector Comment						
DS_ID:19578 FS_ID:39260 EP_NO: N/A Repair Type: Non-Urgent Crossing Status: Found UCIP Comments: 04/25/2014 Dense vegetation limits the inspector's visibility to identify signs of pipe failure (leaks) along the waterward and landward slopes. Recommend removing vegetation along pipe alignment to conduct proper inspection of structure. Sediment buildup inside pipe visible from landward side. Recommend clearing pipe. (DWR UCIP - O. Magana) FIELD_STRUCT_DESC: 24-inch corrugated metal gravity drainage pipe through the levee, 11.5 feet below the crown. Flap gate on the waterside (WS) end. Brass cap No. 50 bench mark (BM) on the headwall on the landside (LS). [Additional Reference(s): DWR Levee Log, 2002. USACE San Joaquin O&M Manual 601.1, 1967, (HLM 17.19)]. FS Date: 4/25/2014

View of waterward side.

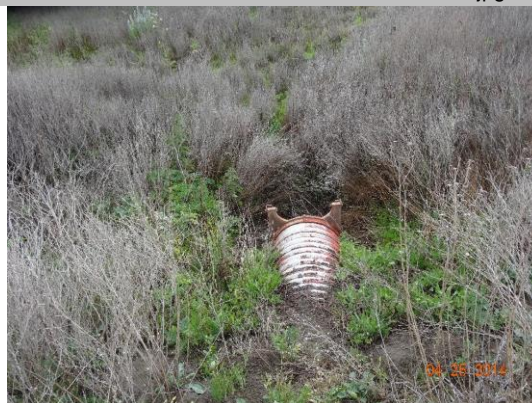
Photo 2 of 3 : UCIP_SP_2020_39260_65521.jpg

Pipe visible on waterward side.

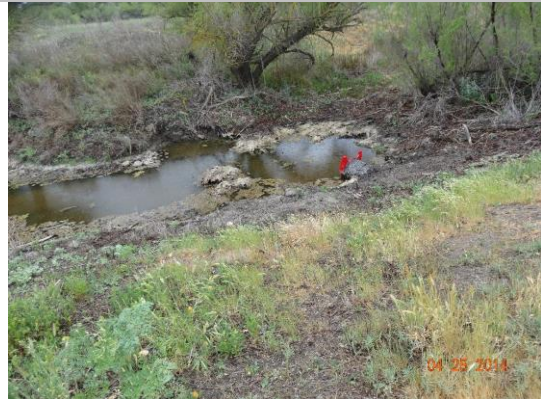
Photo 2 of 3 : UCIP_SP_2020_36203_65552.jpg

Pipe visible on waterward side.

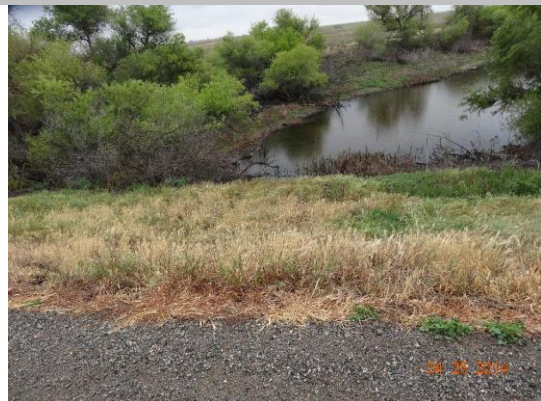
Photo 3 of 3 : UCIP_SP_2020_36203_65554.jpg

View of landward side.

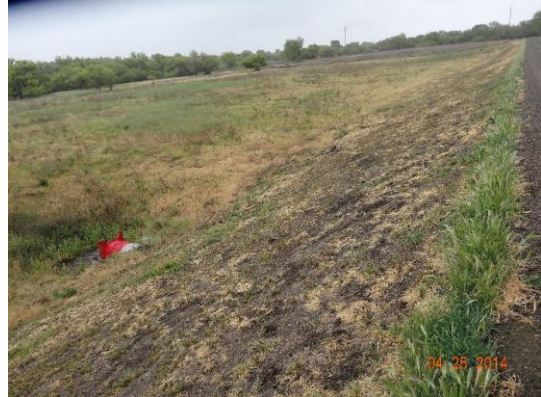
Photo 1 of 3 : UCIP_SP_2020_36204_65547.jpg

Comment Code						
Inspector Comment						
DS_ID:19580 FS_ID:36204 EP_NO: N/A Repair Type: Non-Urgent Crossing Status: Found UCIP Comments: 04/25/2014 Dense vegetation limits the inspector's visibility to identify signs of pipe failure (leaks) along the landward slope. Recommend removing vegetation along pipe alignment to conduct proper inspection of structure. (DWR UCIP - O. Magana) FIELD_STRUCT_DESC: 24-inch corrugated metal gravity drainage pipe through the levee, 9.5 feet below the crown. Flap gate on the waterside (WS) end. Brass cap No. 50 bench mark (BM) on the headwall on the landside (LS). [Additional Reference(s): DWR Levee Log, 2002. USACE San Joaquin O&M Manual 601.1, 1967, (HLM 17.53)]. FS Date: 4/25/2014

View of waterward side.

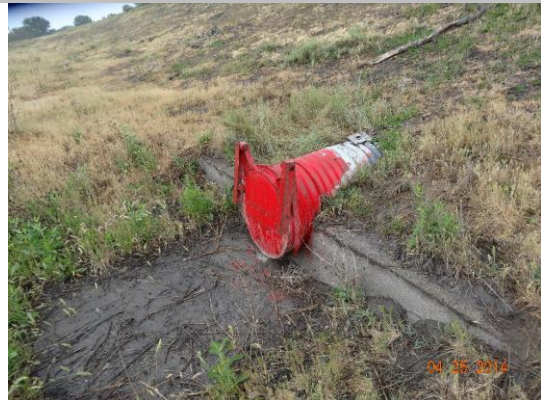
Photo 2 of 3 : UCIP_SP_2020_36204_65546.jpg

Flap gate visible on waterward side.

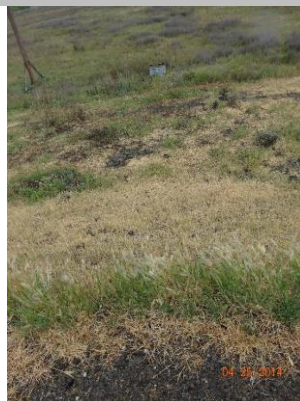
Photo 3 of 3 : UCIP_SP_2020_36204_65545.jpg

View of landward side--riser at levee toe.

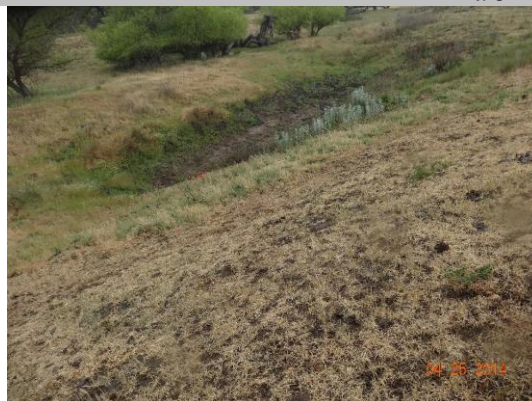
Photo 1 of 3 : UCIP_SP_2020_39261_65557.jpg

Comment Code						
Inspector Comment						
DS_ID:19581 FS_ID:39261 EP_NO: N/A Repair Type: Non-Urgent Crossing Status: Found UCIP Comments: 04/25/2014 Need to contact owner. Recommend investigating integrity of pipe wall through levee heavy corrosion visible from landward side. (DWR UCIP - O. Magana) FIELD_STRUCT_DESC: 24-inch corrugated metal gravity drainage pipe through the levee, 11.5 feet below the crown. Flap gate on the waterside (WS) end. Brass cap No. 50 bench mark (BM) on the headwall on the landside (LS). [Additional Reference(s): DWR Levee Log, 2002. USACE San Joaquin O&M Manual 601.1, 1967, (HLM 18.19)]. FS Date: 4/25/2014

View of waterward side.

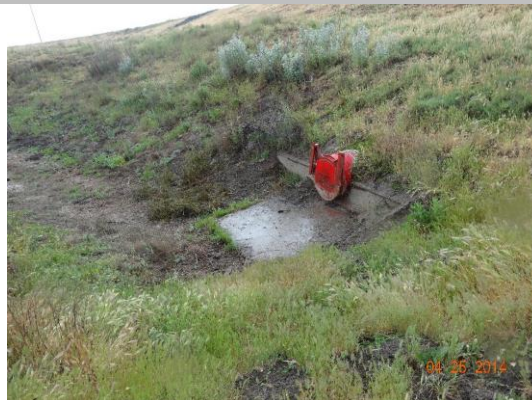
Photo 2 of 3 : UCIP_SP_2020_39261_65556.jpg

Flap gate visible on waterward side.

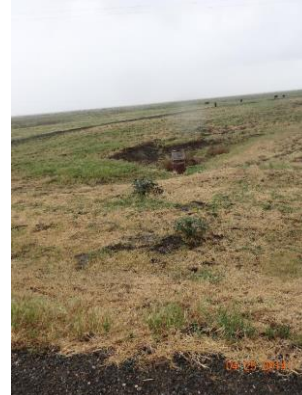
Photo 3 of 3 : UCIP_SP_2020_39261_65555.jpg

View of landward side.

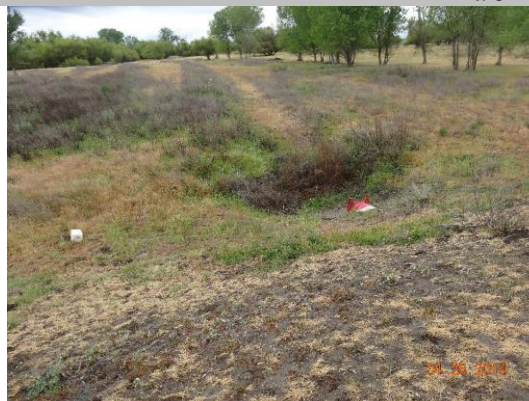
Photo 1 of 3 : UCIP_SP_2020_36206_65563.jpg

DS_ID:19582
 FS_ID:36206
 EP_NO: N/A
 Repair Type: No Action Needed
 Crossing Status: Found
 UCIP Comments:
 FIELD_STRUCT_DESC: 24-inch corrugated metal gravity drainage pipe through the levee, 9.4 feet below the crown. Flap gate on the waterside (WS) end. Brass cap No. 50 bench mark (BM) on the headwall on the landside (LS). [Additional Reference(s): DWR Levee Log, 2002. USACE San Joaquin O&M Manual 601.1, 1967, (HLM 18.45)].
 FS Date: 4/25/2014

View of waterward side.

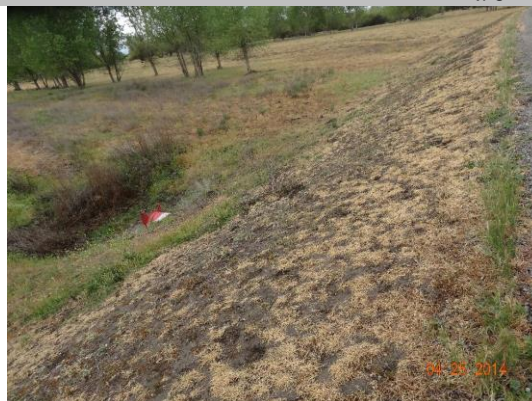
Photo 2 of 3 : UCIP_SP_2020_36206_65562.jpg

View of waterward slope.

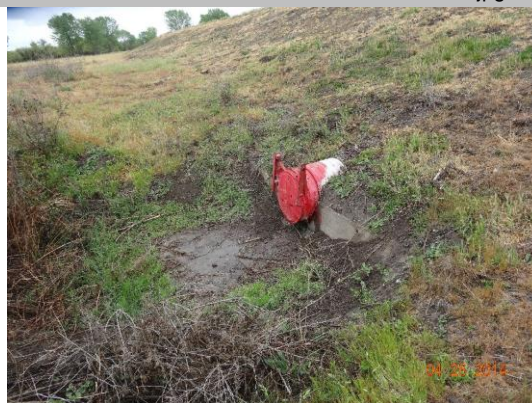
Photo 3 of 3 : UCIP_SP_2020_36206_65561.jpg

Flap gate visible on waterward side.

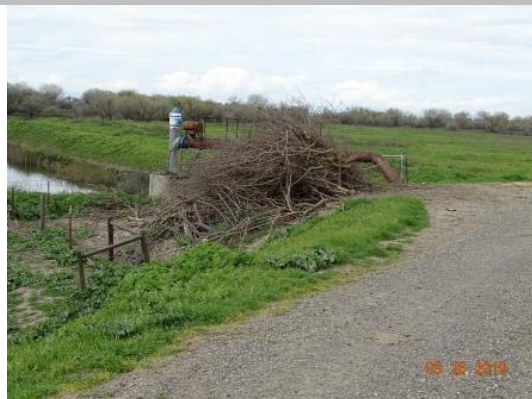
Photo 1 of 1 : SP_2020_NA0010_118_134_20200225_00042.jpg

LM Start	18.77	Rating **	U	Issue No.	134
LM End	18.77	Issue Type +	En	Location *	WS
Category	Earthen Levee			GPS Latitude/Longitude	
				Start	End
Item	Encroachments			37.205064 °	37.205064 °
				-120.762721 °	-120.762721 °
DWR ID	DWR_NA0010_01_s_2019_134				
Comment Code					
PR : Prunings					
Inspector Comment

View of prunings on waterside slope. (Spring 2019)

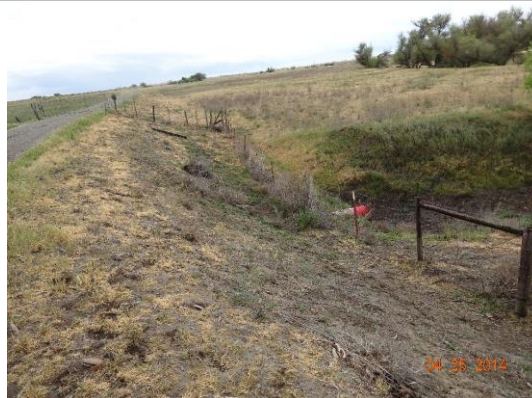
Photo 2 of 3 : UCIP_SP_2020_36246_65623.jpg

View of waterward side.

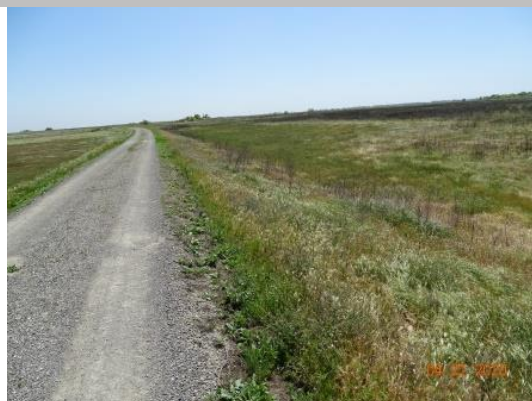
Photo 1 of 1 : SP_2020_NA0010_118_161_20200506_00304.jpg

LM Start	18.83	Rating **	U	Issue No.	161
LM End	20.34	Issue Type +	Ma	Location *	WS
Category	Earthen Levee			GPS Latitude/Longitude	
				Start	End
Item	Vegetation			37.204612 °	37.192695 °
				-120.761886 °	-120.761030 °
DWR ID	DWR_NA0010_01_s_2020_161				
Comment Code					
V1 : Control annual grass and weeds on the levee slopes and easements.					
Inspector Comment

View of vegetation on the waterside slope. (Spring 2020)

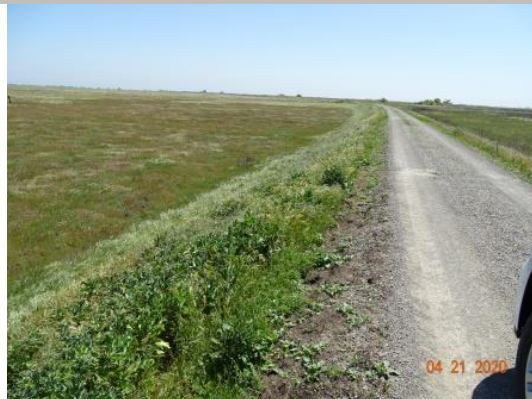
Photo 1 of 1 : SP_2020_NA0010_118_160_20200506_00305.jpg

LM Start	18.83	Rating **	U	Issue No.	160
LM End	20.37	Issue Type +	Ma	Location *	LS
Category	Earthen Levee			GPS Latitude/Longitude	
				Start	End
Item	Vegetation			37.204612 °	37.192277 °
				-120.761886 °	-120.761263 °
DWR ID	DWR_NA0010_01_s_2020_160				
Comment Code					
V1 : Control annual grass and weeds on the levee slopes and easements.					
Inspector Comment

View of the landside slope looking upstream. (Spring 2020)

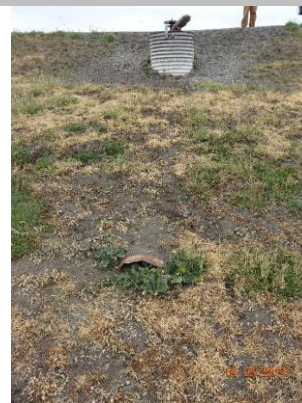
Photo 1 of 3 : UCIP_SP_2020_39263_65631.jpg

Comment Code						
Inspector Comment						
DS_ID:19594 FS_ID:39263 EP_NO: N/A Repair Type: Non-Urgent Crossing Status: Found UCIP Comments: 04/25/2014 Non-functional crossing--pipe is buried on waterward side. Sediment buildup in pipe visible from landward side. Need to coordinate with owner to determine status. If crossing is no longer in use, owner will need to coordinate with DWR Inspector and CVFPB to properly abandon. (DWR UCIP - O. Magana) FIELD_STRUCT_DESC: 24-inch corrugated metal gravity drainage pipe through the levee, 13 feet below the crown. Flap gate on the waterside (WS) end. Brass cap No. 40 bench mark (BM) on the headwall on the landside (LS). [Additional Reference(s): DWR Levee Log, 2002. USACE San Joaquin O&M Manual 601.1, 1967, (HLM 19.17)]. FS Date: 4/25/2014

View of waterward slope. CMP riser and pipe visible.

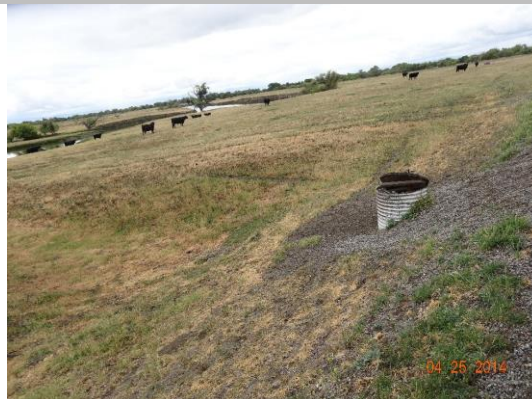
Photo 2 of 3 : UCIP_SP_2020_39263_65630.jpg

View of waterward side.

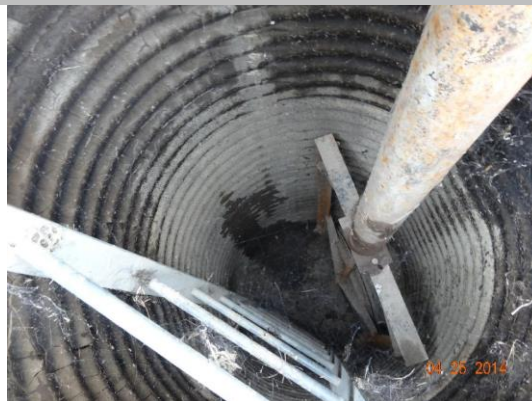
Photo 3 of 3 : UCIP_SP_2020_39263_65632.jpg

Inside view of CMP riser.

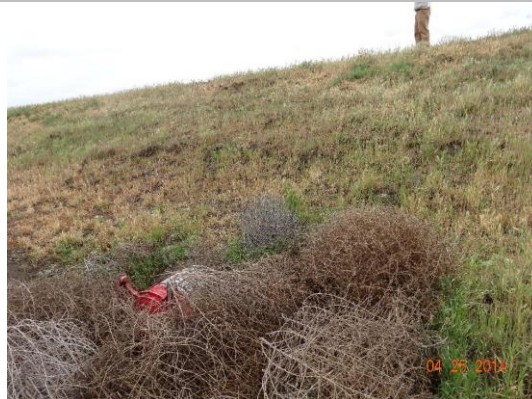
Photo 2 of 3 : UCIP_SP_2020_39268_65640.jpg

Flap gate visible on waterward side--potential erosion present on slope.

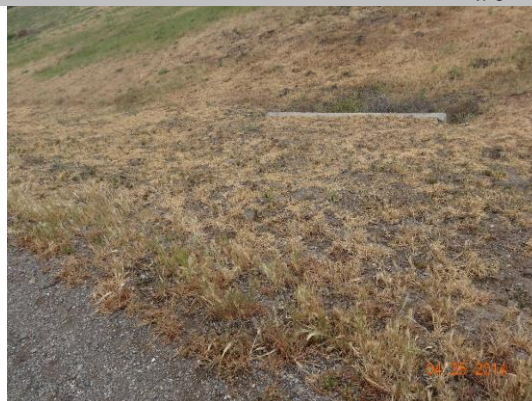
Photo 3 of 3 : UCIP_SP_2020_39268_65639.jpg

View of landward slope.

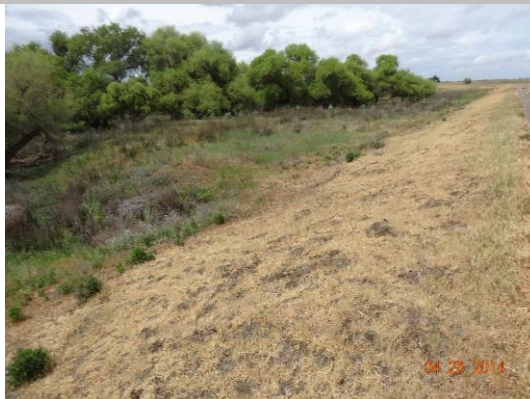
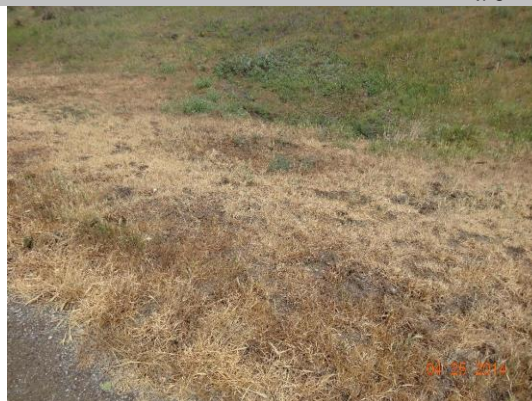
LM Start	20.18	Rating **	M	Issue No.	1261	
LM End	20.18	Issue Type +	Ma	Location *		
Category	Supplemental			GPS Latitude/Longitude		
				Start		End
Item	DWR UCIP LMA Responsibility			37.194669 °		37.194669 °
				-120.759736 °		-120.759736 °
DWR ID	19598					
Comment Code						
Inspector Comment						
DS_ID:19598 FS_ID:39269 EP_NO: N/A Repair Type: Non-Urgent Crossing Status: Found UCIP Comments: 04/25/2014 Recommend removing vegetation and sediment buildup from both waterward and landward concrete headwalls. (DWR UCIP - O. Magana) FIELD_STRUCT_DESC: 24-inch corrugated metal gravity drainage pipe through the levee, 8.5 feet below the crown. Flap gate on the waterside (WS) end. Brass cap No. 40 bench mark (BM) on the headwall on the landside (LS). [Additional Reference(s): DWR Levee Log, 2002. USACE San Joaquin O&M Manual 601.1, 1967, (HLM 20.18)]. FS Date: 4/25/2014

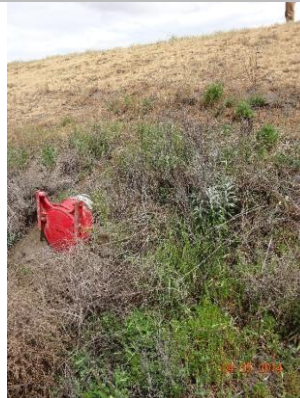
Photo 2 of 3 : UCIP_SP_2020_39269_65647.jpg

Flap gate visible on WS toe.

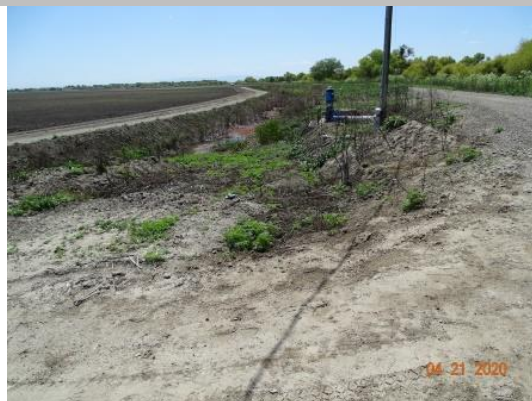
Photo 1 of 1 : SP_2020_NA0010_118_1184_20200506_00307.jpg

LM Start	20.25	Rating **	U	Issue No.	1184
LM End	20.25	Issue Type +	En	Location *	LS
Category	Earthen Levee			GPS Latitude/Longitude	
				Start	End
Item	Encroachments			37.193657 °	37.193657 °
				-120.760138 °	-120.760138 °
DWR ID	DWR_NA0010_01_s_2015_1184				
Comment Code					
RA : Ramp					
Inspector Comment					
Landowner installed unauthorized ramp on landside slope and toe.

Ramp cut into to the landside slope to access irrigation ditch at the landside toe. (Spring 2020)

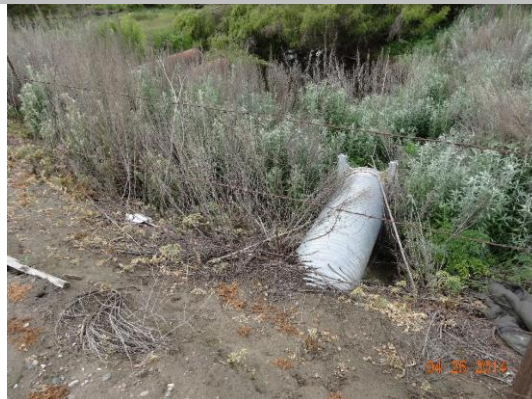
Photo 2 of 3 : UCIP_SP_2020_49965_66304.jpg

View of WS.

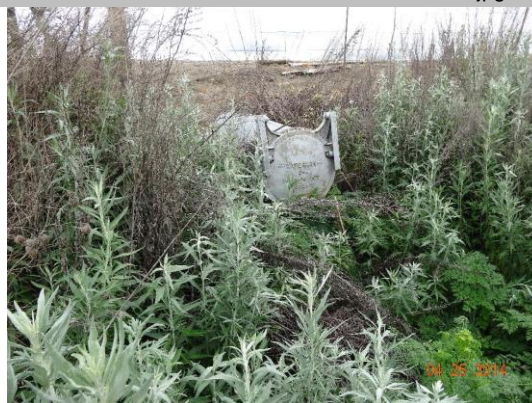
Photo 3 of 3 : UCIP_SP_2020_49965_66302.jpg

View of WS.

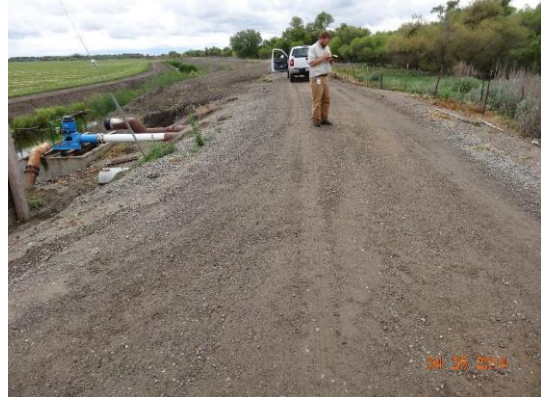
Photo 1 of 3 : UCIP_SP_2020_39878_66308.jpg

Comment Code						
Inspector Comment						
DS_ID:19600 FS_ID:39878 EP_NO: N/A Repair Type: Non-Urgent Crossing Status: Found UCIP Comments: 04/25/2014 Crossing partially submersed--no signs of failure of pipe present along pipe alignment. Recommend contacting owner to determine status of crossing and condition. (DWR UCIP - O. Magana) FIELD_STRUCT_DESC: 36-inch corrugated metal gravity drainage pipe through the levee, 10.5 feet below the crown. Flap gate on the waterside (WS) end. Brass cap No. 40 bench mark (BM) on the headwall on the landside (LS). [Additional Reference(s): DWR Levee Log, 2002. USACE San Joaquin O&M Manual 601.1, 1967, (HLM 20.27)]. FS Date: 4/25/2014

Overview of levee crown at crossing--multiple crossings at this location.

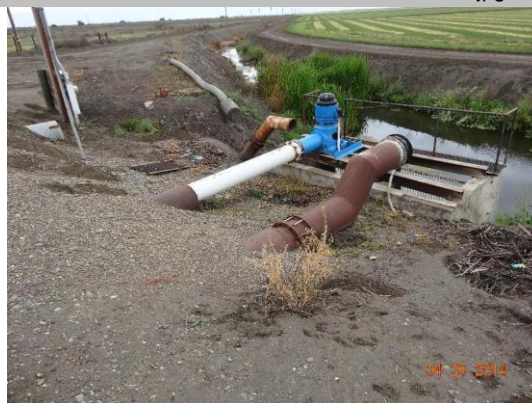
Photo 3 of 3 : UCIP_SP_2020_39286_71440.jpg

View of landward side.

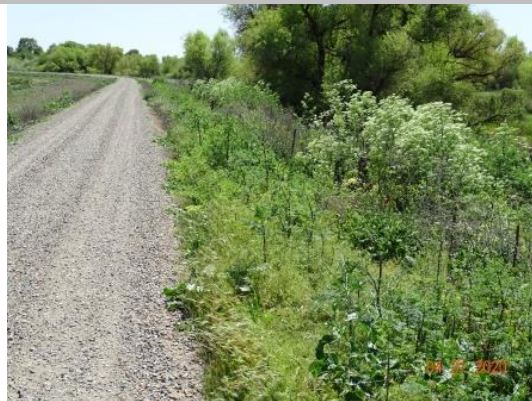
Photo 1 of 1 : SP_2020_NA0010_118_164_20200506_00308.jpg

LM Start	21.15	Rating **	U	Issue No.	164
LM End	21.54	Issue Type +	Ma	Location *	WS
Category	Earthen Levee			GPS Latitude/Longitude	
				Start	End
Item	Vegetation			37.182402 °	37.178338 °
				-120.763089 °	-120.759317 °
DWR ID	DWR_NA0010_01_s_2020_164				
Comment Code					
V1 : Control annual grass and weeds on the levee slopes and easements.					
Inspector Comment

Control vegetation on the waterside shoulder. (Spring 2020)

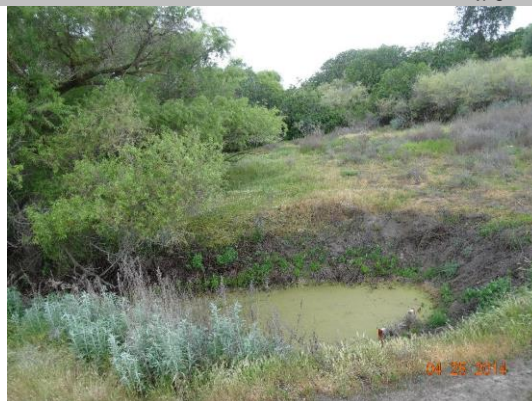
Photo 1 of 3 : UCIP_SP_2020_39271_66312.jpg

Comment Code						
Inspector Comment						
DS_ID:19603 FS_ID:39271 EP_NO: N/A Repair Type: Non-Urgent Crossing Status: Found UCIP Comments: 04/25/2014 Crossing is non-functional--crossing buried on landward side. Need to contact owner to determine status of crossing. If crossing is no longer used need to coordinate with CVFPB for proper abandonment. (DWR UCIP - O. Magana) FIELD_STRUCT_DESC: 36-inch corrugated metal gravity drainage pipe through the levee, 11.5 feet below the crown. Flap gate on the waterside (WS) end. Brass cap No. 40 bench mark (BM) on the headwall on the landside (LS). [Additional Reference(s): DWR Levee Log, 2002. USACE San Joaquin O&M Manual 601.1, 1967, (HLM 21.40)]. FS Date: 4/25/2014

View of waterward side.

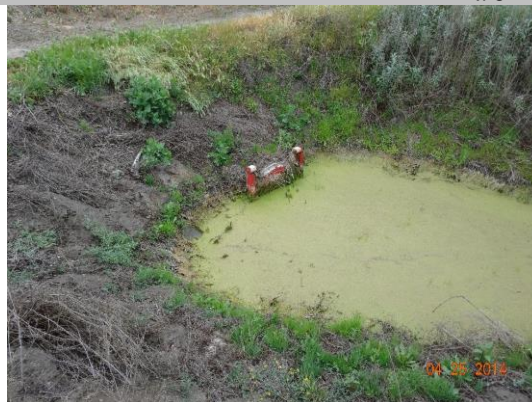
Photo 2 of 3 : UCIP_SP_2020_39271_66313.jpg

Flap gate half way submersed located on waterward side.

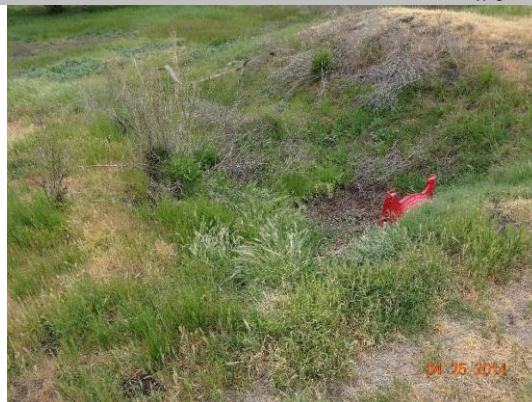
Photo 2 of 3 : UCIP_SP_2020_39272_65695.jpg

Flap gate visible on waterward side.

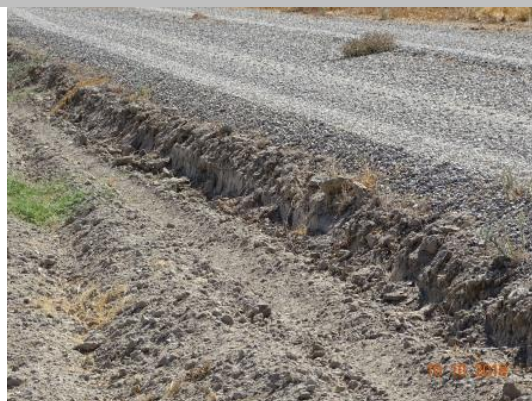
Photo 1 of 1 : SP_2020_NA0010_118_130_20200225_00040.jpg

LM Start	21.99	Rating **	M	Issue No.	130
LM End	22.01	Issue Type +	En	Location *	LS
Category	Earthen Levee			GPS Latitude/Longitude	
				Start	End
Item	Encroachments			37.173001 °	37.172668 °
				-120.755115 °	-120.754933 °
DWR ID	DWR_NA0010_01_f _ 2018_130				
Comment Code					
AT : Agricultural tilling					
Inspector Comment					
Tilling along landside toe partially cut into the slope.

View of tilling from toe looking towards the levee. (Fall 2018)

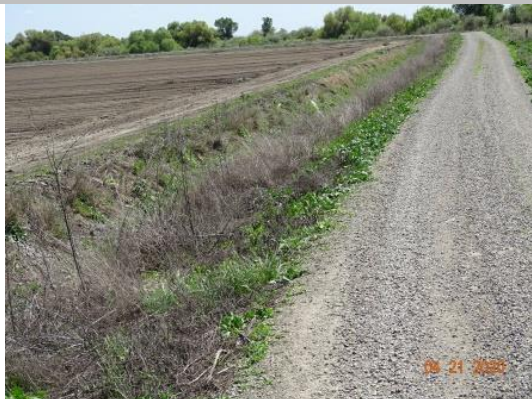
Photo 1 of 1 : SP_2020_NA0010_118_168_20200506_00310.jpg

LM Start	22.05	Rating **	U	Issue No.	168
LM End	22.51	Issue Type +	Ma	Location *	LS
Category	Earthen Levee			GPS Latitude/Longitude	
				Start	End
Item	Vegetation			37.172138 °	37.166962 °
				-120.754645 °	-120.750063 °
DWR ID	DWR_NA0010_01_s_2020_168				
Comment Code					
V1 : Control annual grass and weeds on the levee slopes and easements.					
Inspector Comment

View of the landside slope looking upstream. (Spring 2020)
